ENGINEERING CASE LIBRARY

THE (Delinquent) DRAWBAR (A)

A study of the circumstances surrounding an accident involving a tank train hauling gasoline. The train overturned on an exit ramp from an interstate highway, caught fire and burned, completely destroying the tank train and cargo. A key question was whether the drawbar between the semi-trailer and full trailer broke after the start of the accident or whether it broke before the accident and thus was the initiating cause.

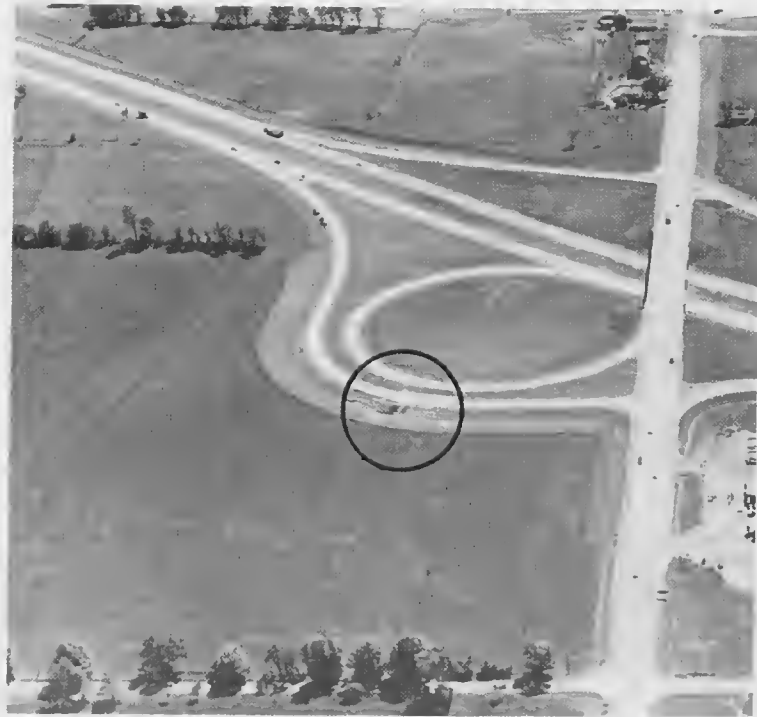
The accident occurred at the intersection of I-94 and U. S. 27 as indicated in Figure 1. The driver was west-bound on I-94 and was on the exit ramp when the rig overturned and burned. It was daylight with clear and sunny weather. The ramp was concrete and dry with no significant defects. The train overturned at a distance of 300-400 ft. from U. S. 27. The ramp has a radius of about 300 ft. with a slight up-grade at that point.

Fig. 1: Intersection of E-W I-94 and N-S U.S. 27, looking southward. Circle indicates location of tank train after overturning and catching fire.
